**REPORT NO. 01-16**

**M871A3 TACTICAL TRAILER**  
**22.5-TON PAYLOAD CAPACITY**  
**TP-94-01,**  
**“TRANSPORTABILITY TESTING PROCEDURES”**

**M871 Tactical Trailer, 22.5-Ton Payload Capacity  
TP-94-01, "Transportability Testing Procedures"**

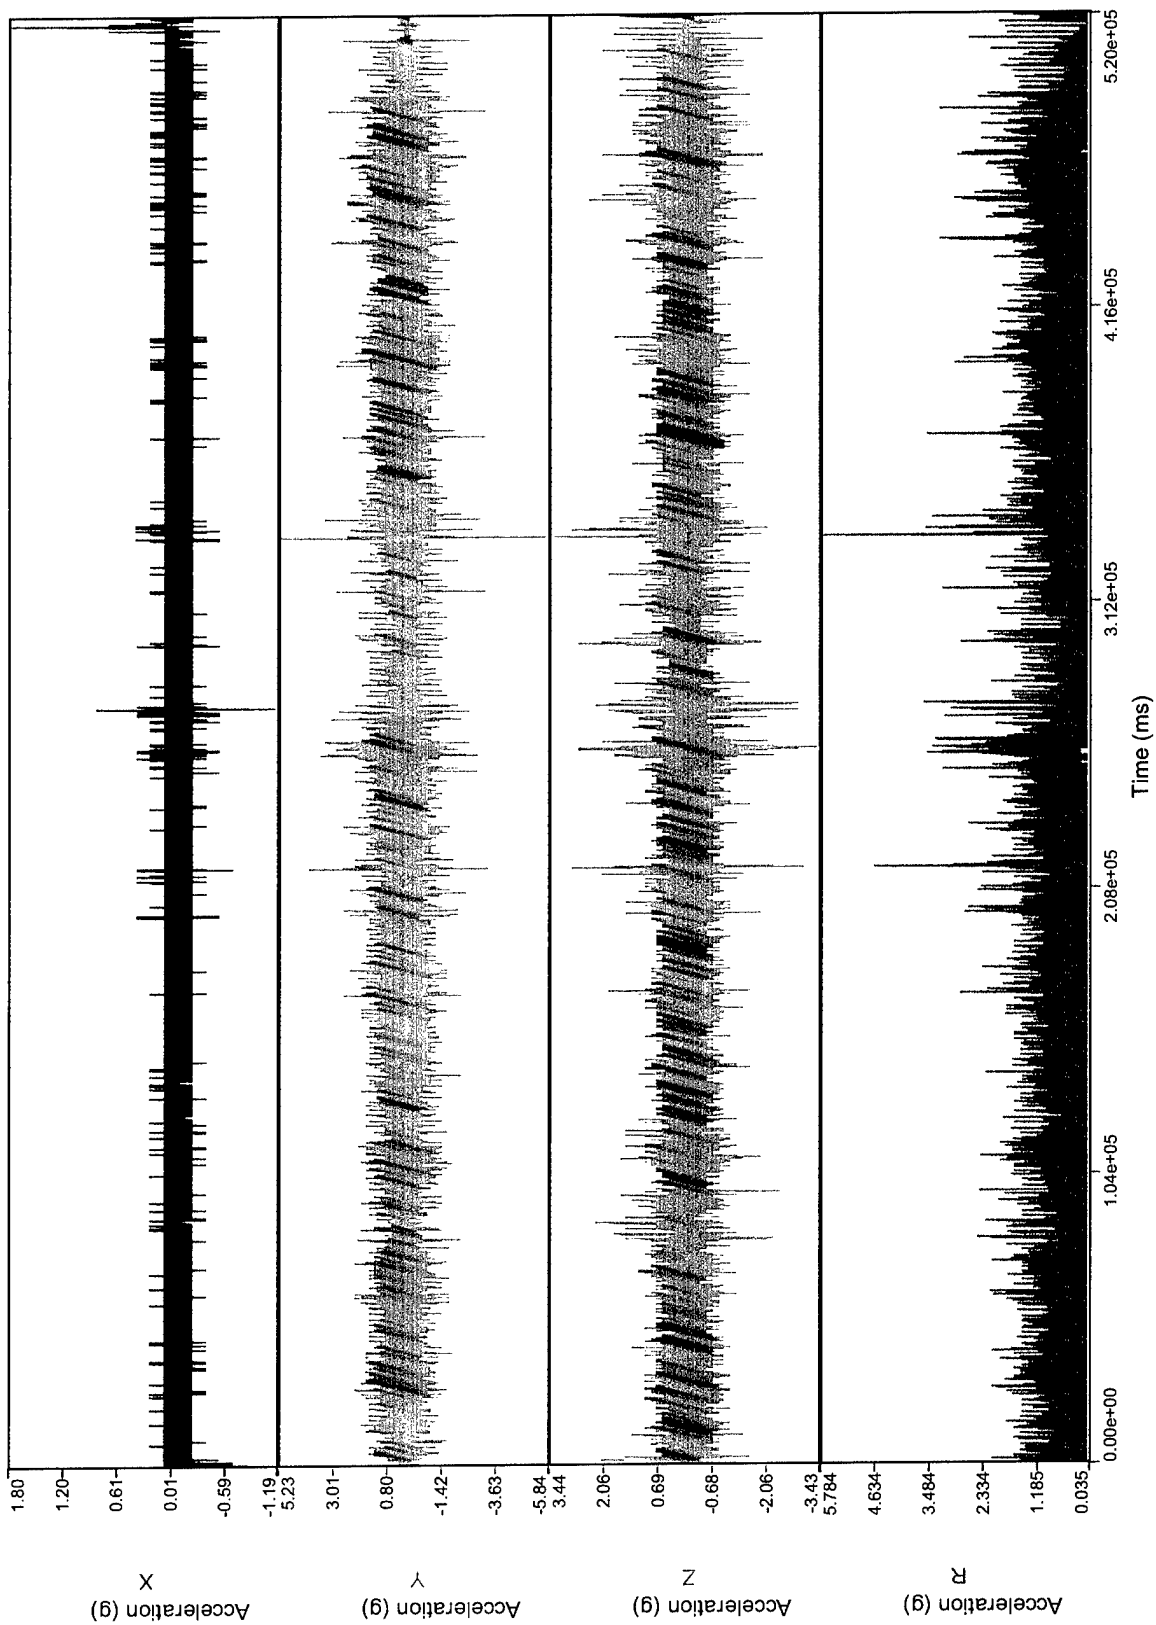
Road Trip of M871A3 Trailer with 11,859-lb Payload      Sensor Location: Trailer Rear

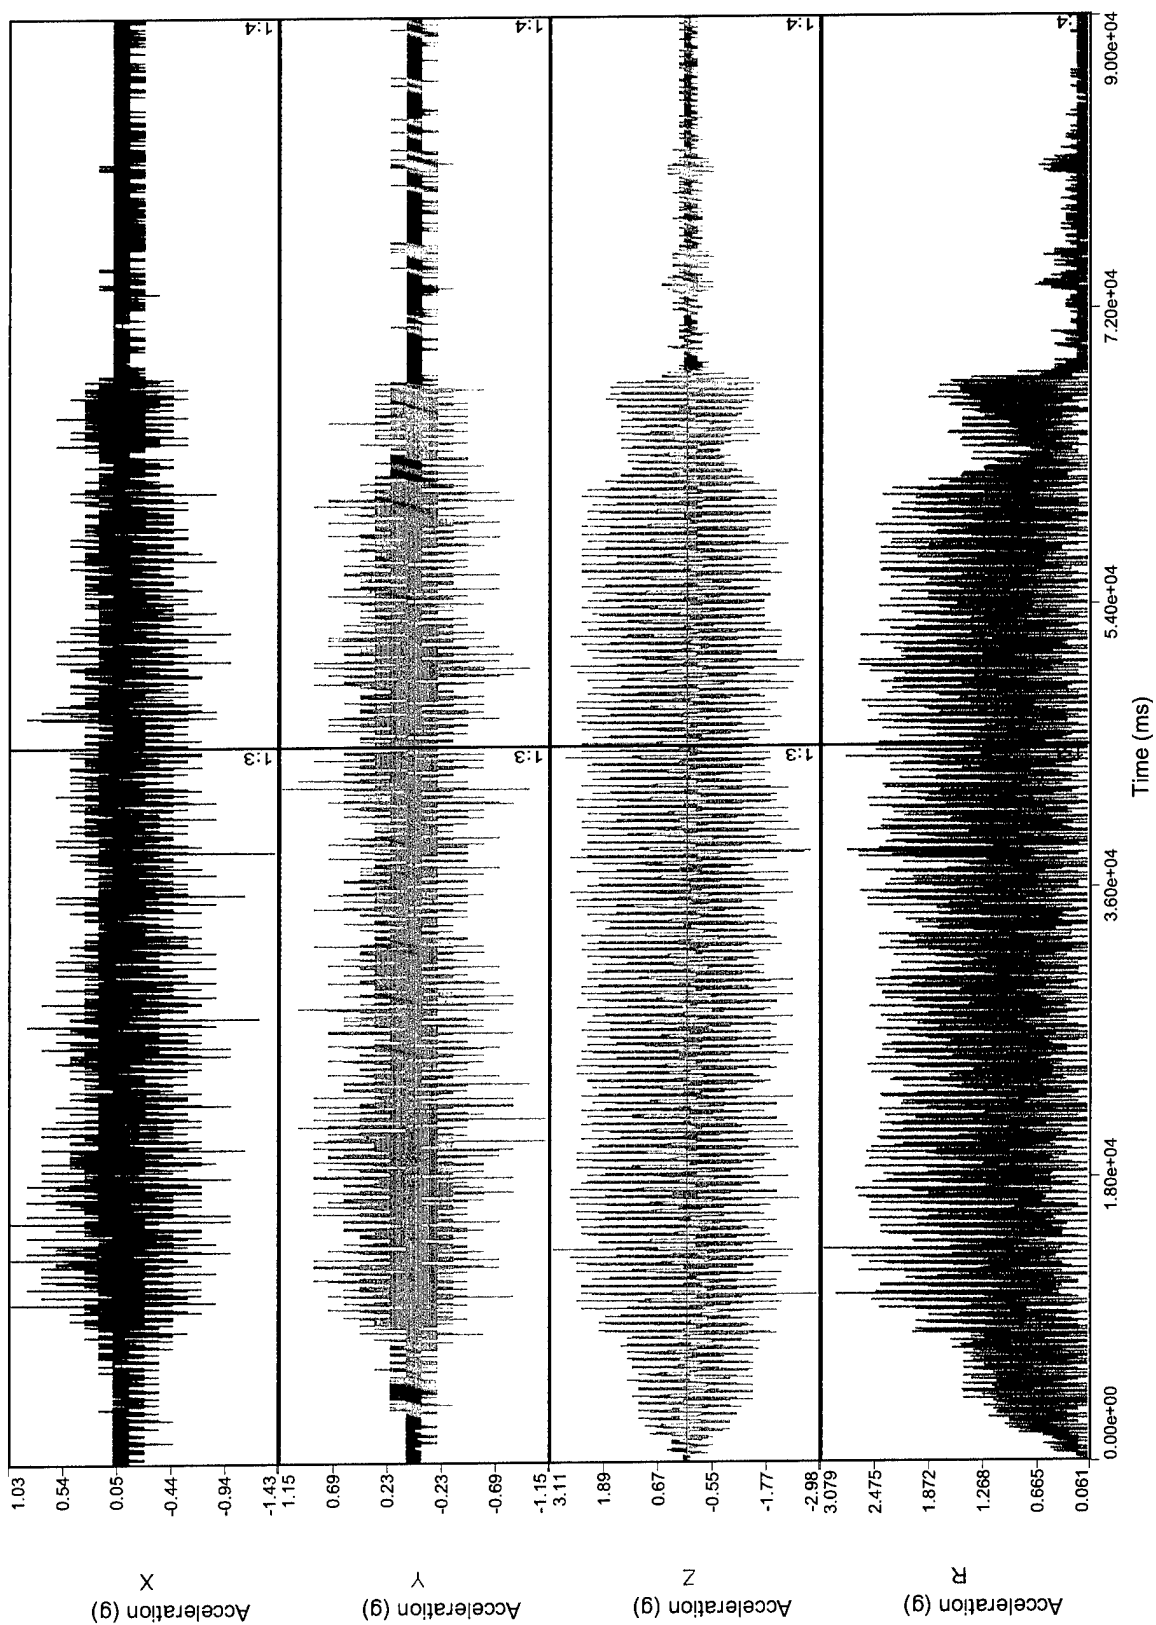
Washboard Course of M87/A3 Trailer with 11,859-lb Payload

Sensor Location: Trailer Bulkhead

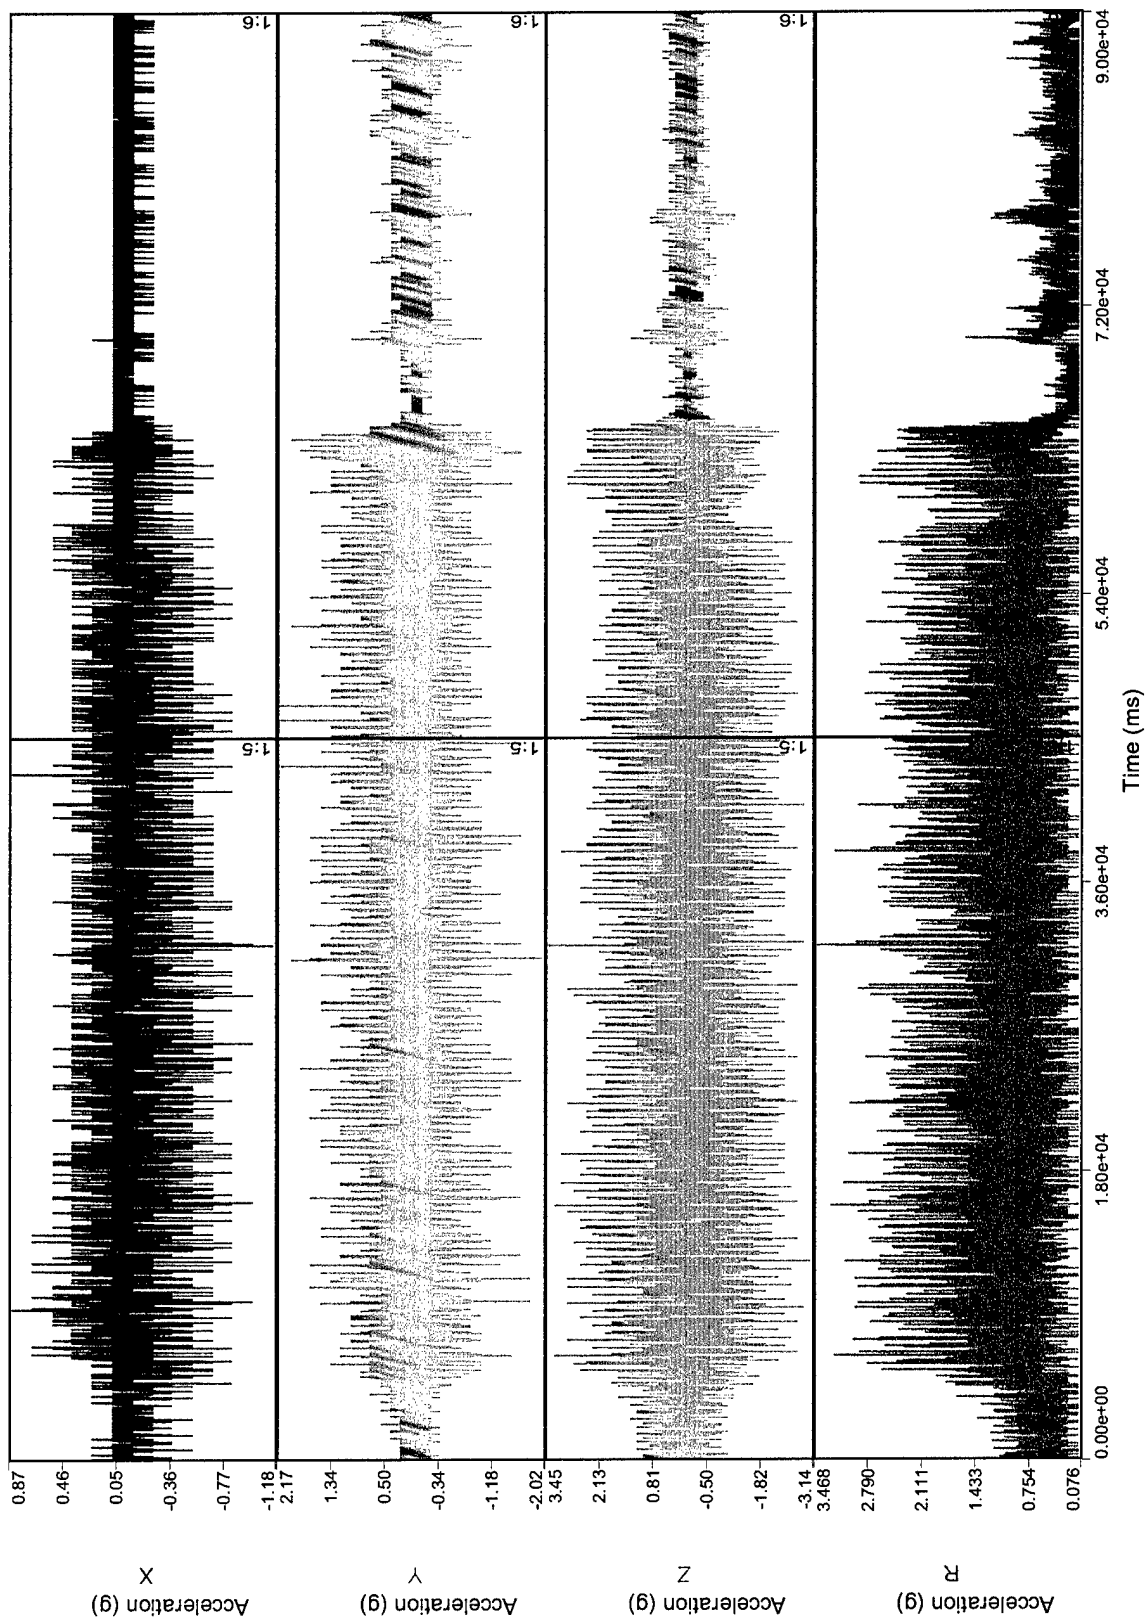
Washboard Course of M871A3 Trailer with 11,859-lb Payload

Sensor Location: Trailer Rear

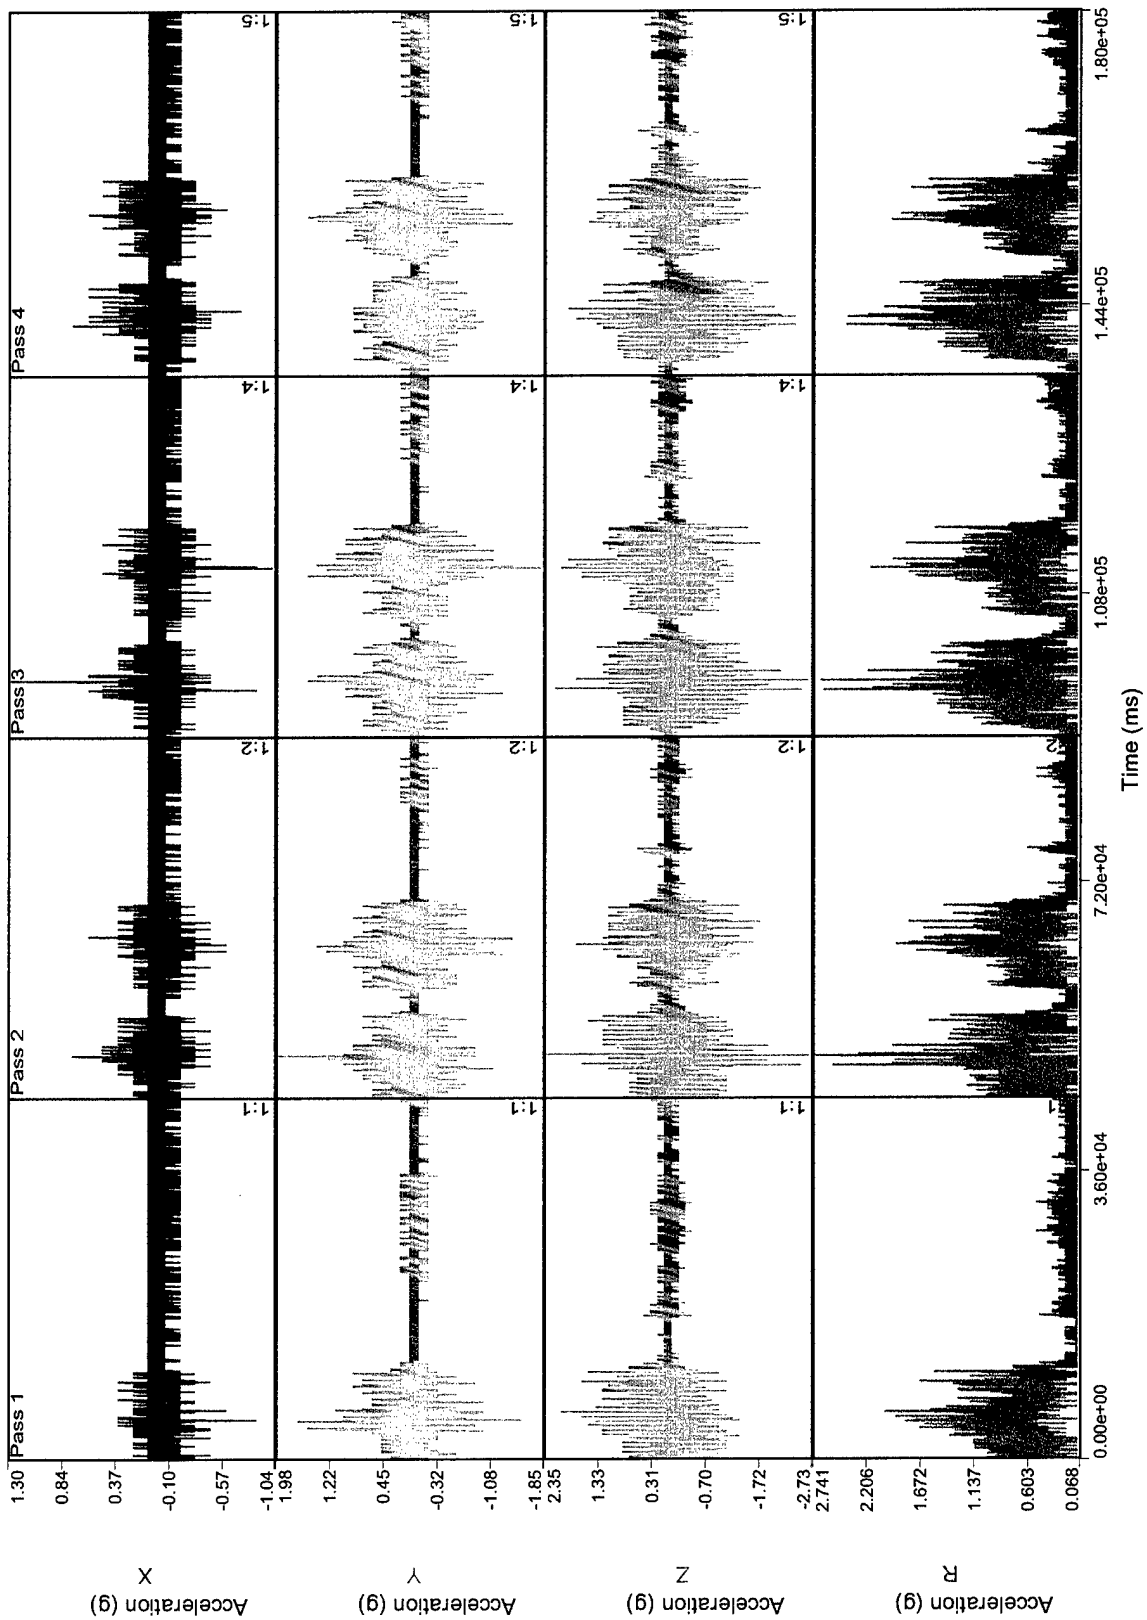
Hazard Course of M871A3 Trailer with 45,180-lb Payload      Sensor Location: Trailer Bulkhead

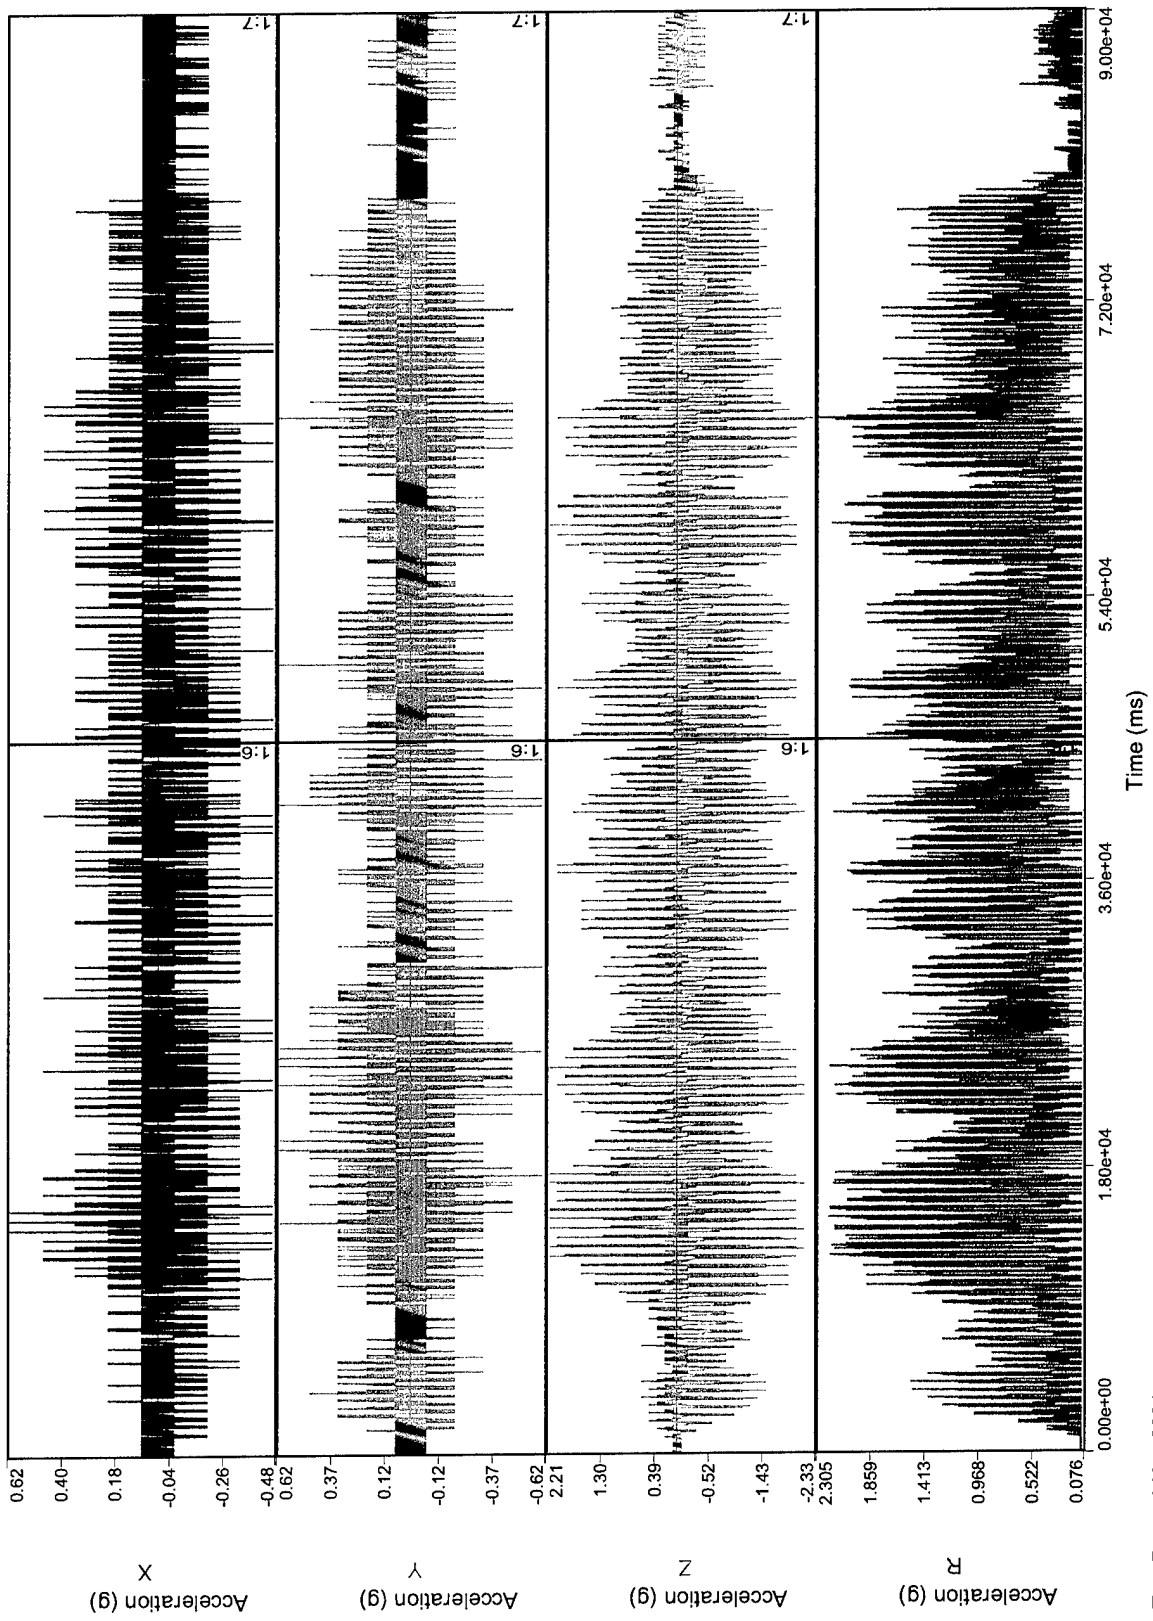
Dashboard Course of M871A3 Trailer with 45,180-lb Payload      Sensor Location: Trailer Bulkhead

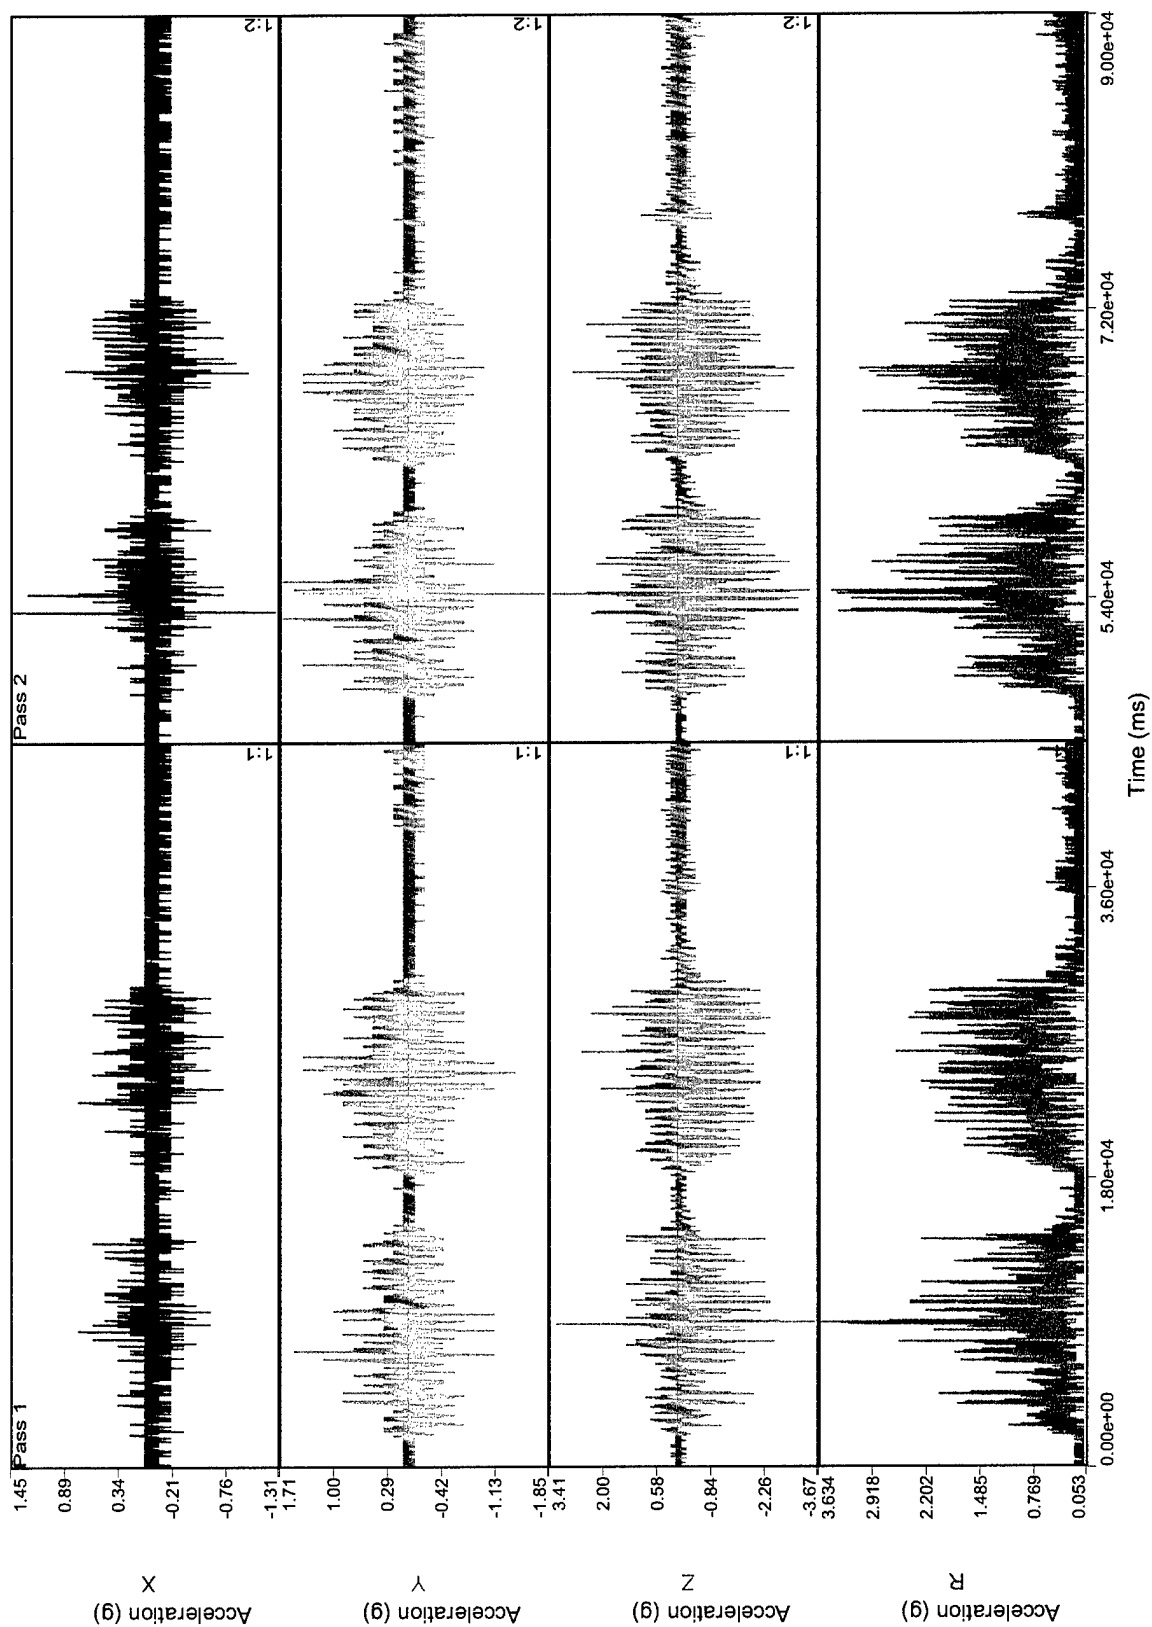
Hazard Course of M871A3 Trailer with 33,940-lb Payload      Sensor Location: Trailer Bulkhead

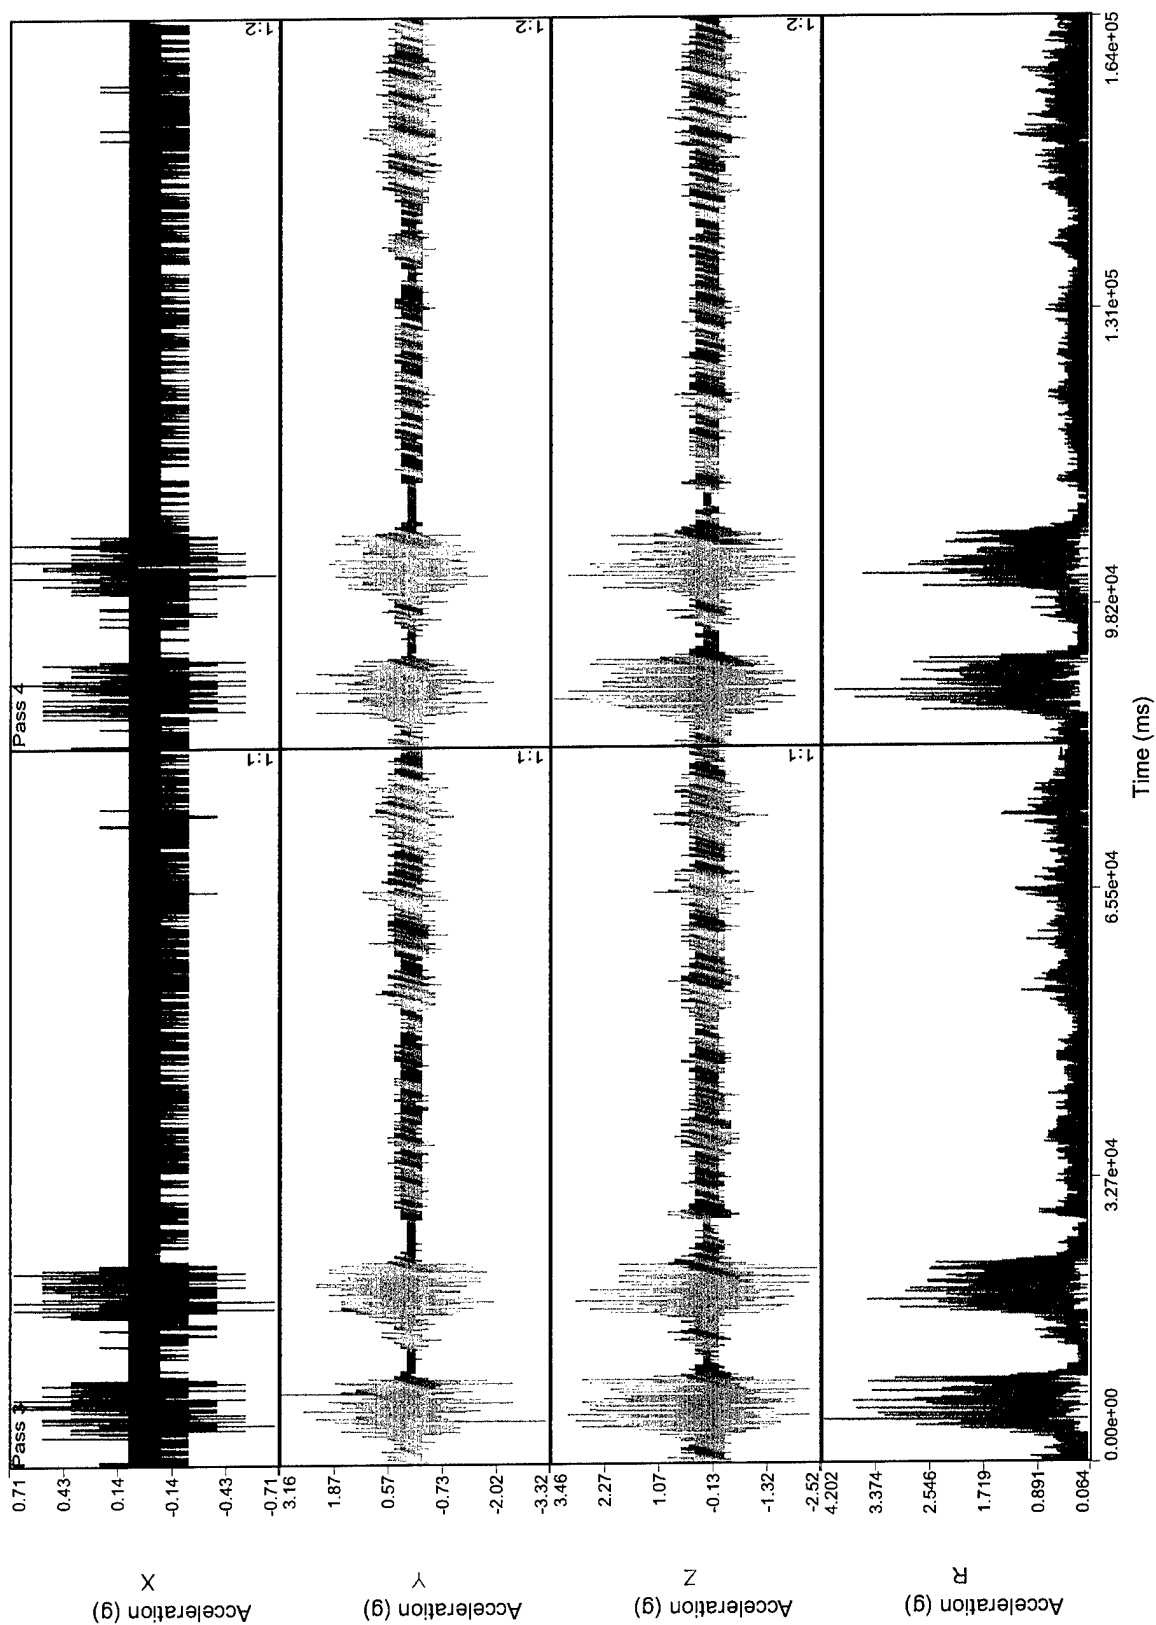
Hazard Course of M871A3 Trailer with 33,940-lb Payload      Sensor Location: Trailer Bulkhead

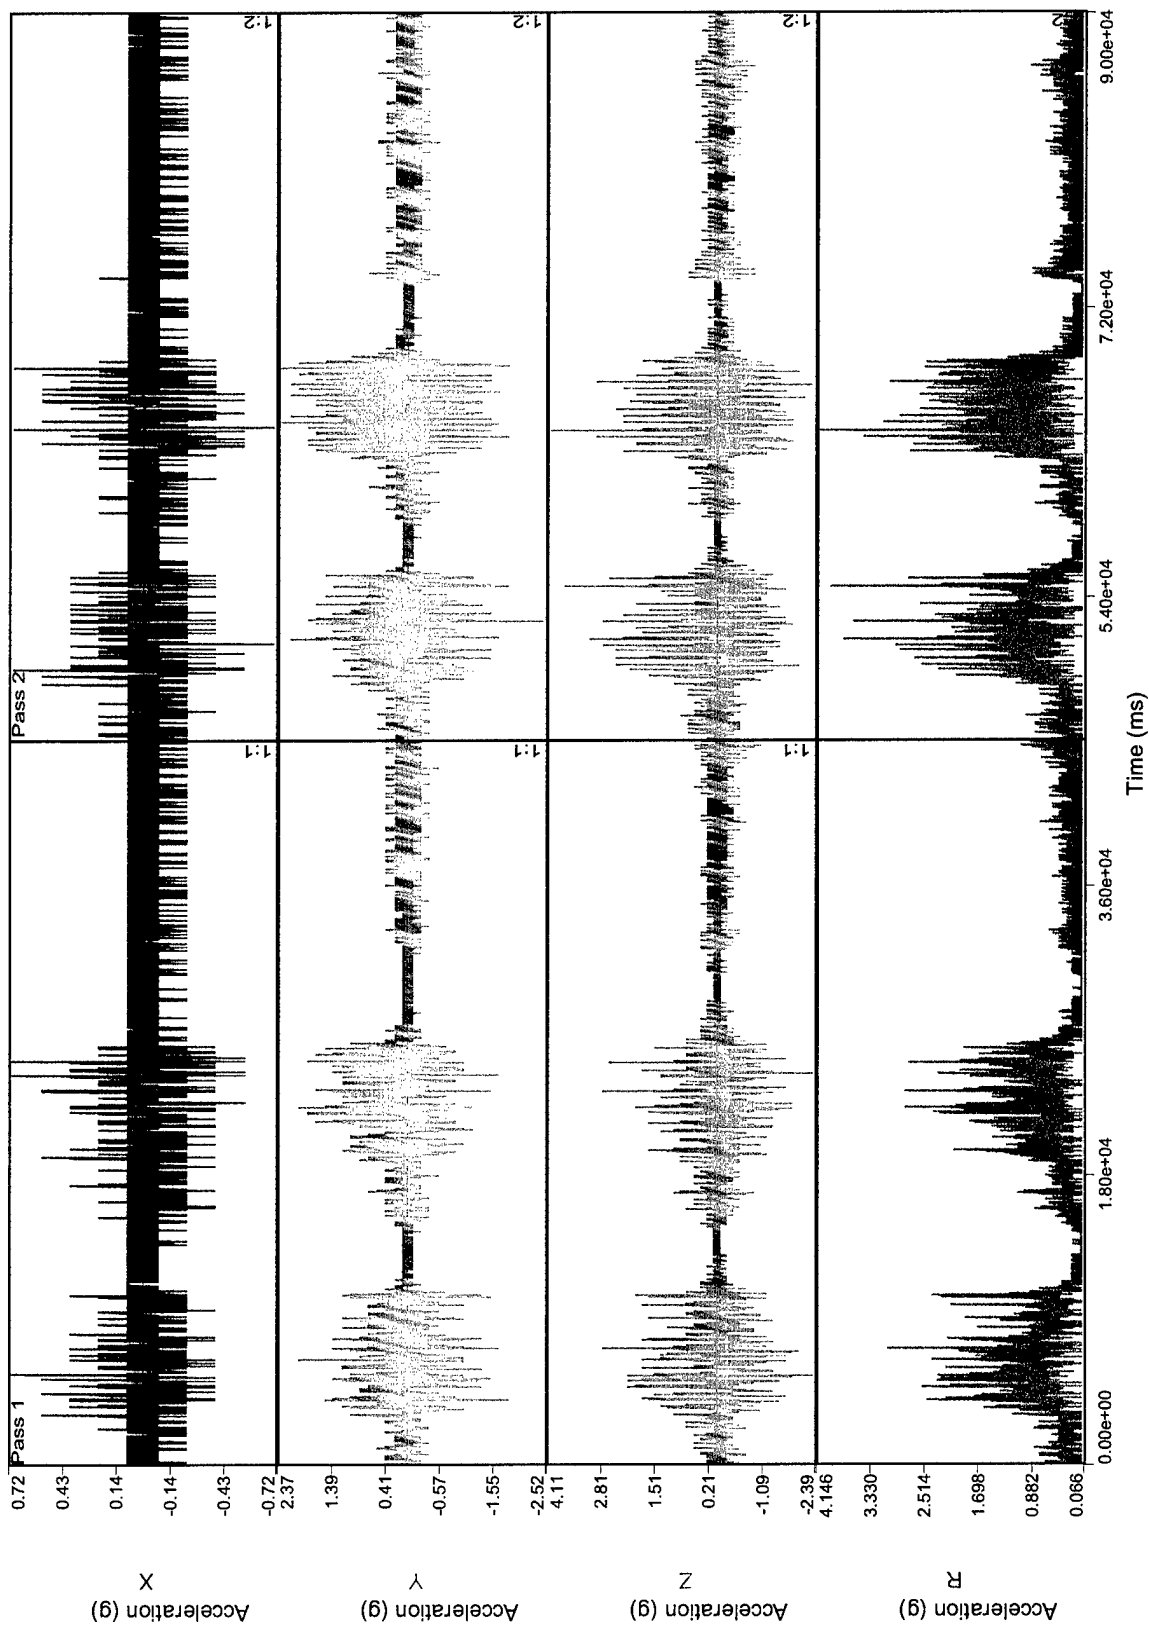
Hazard Course of M871A3 Trailer with 33,940-lb Payload      Sensor Location: Trailer Rear

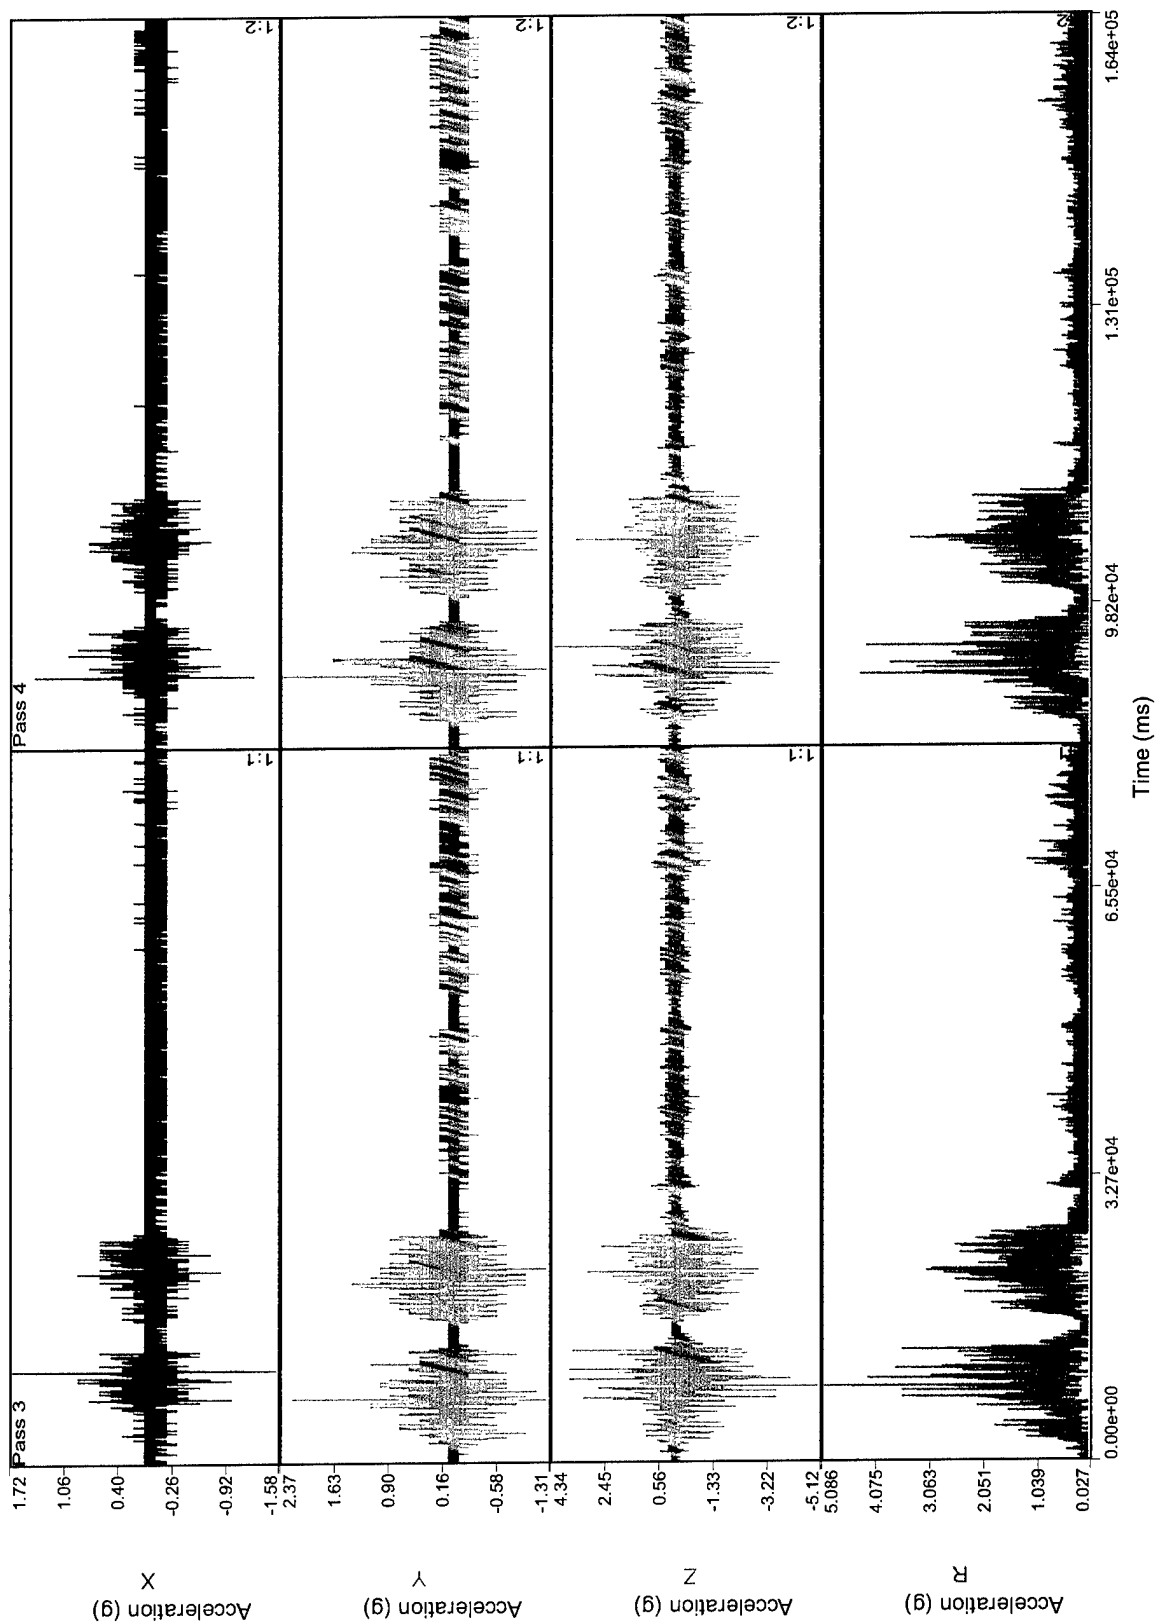
Hazard Course of M871A3 Trailer with 33,940-lb Payload      Sensor Location: Trailer Rear

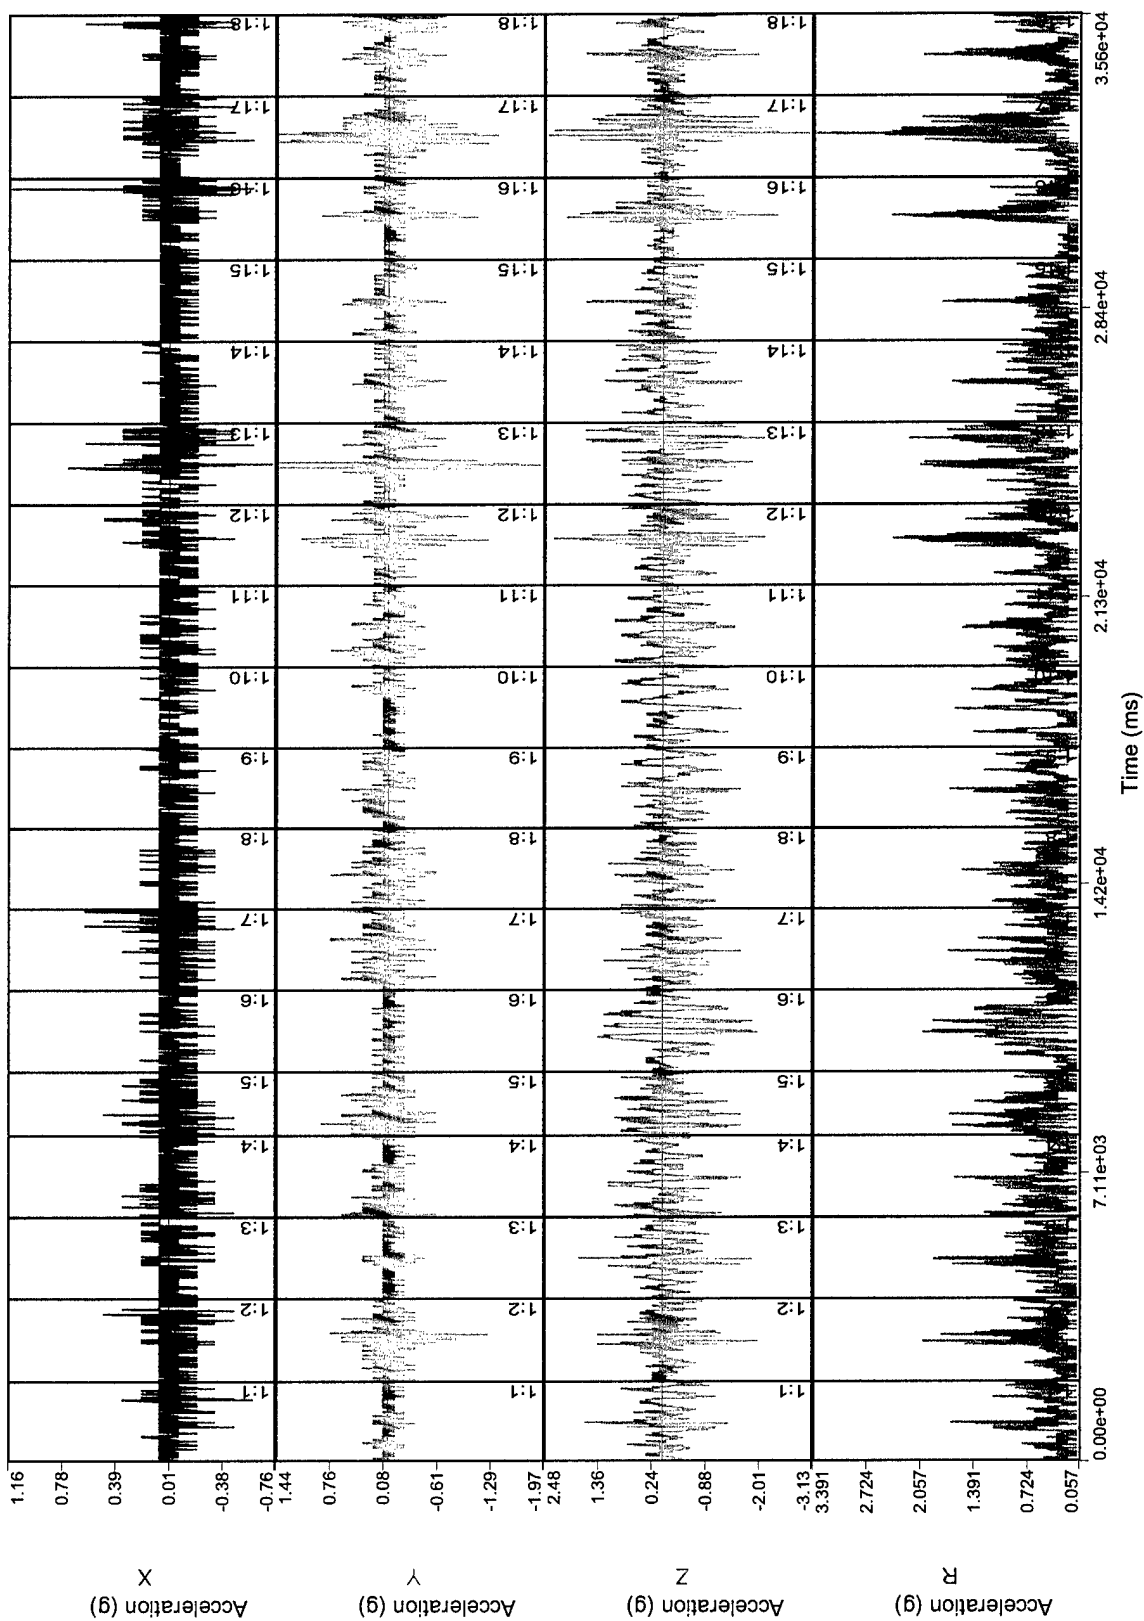
Road Trip of M871A3 Trailer with 33,940-lb Payload

Sensor Location: Trailer Bulkhead

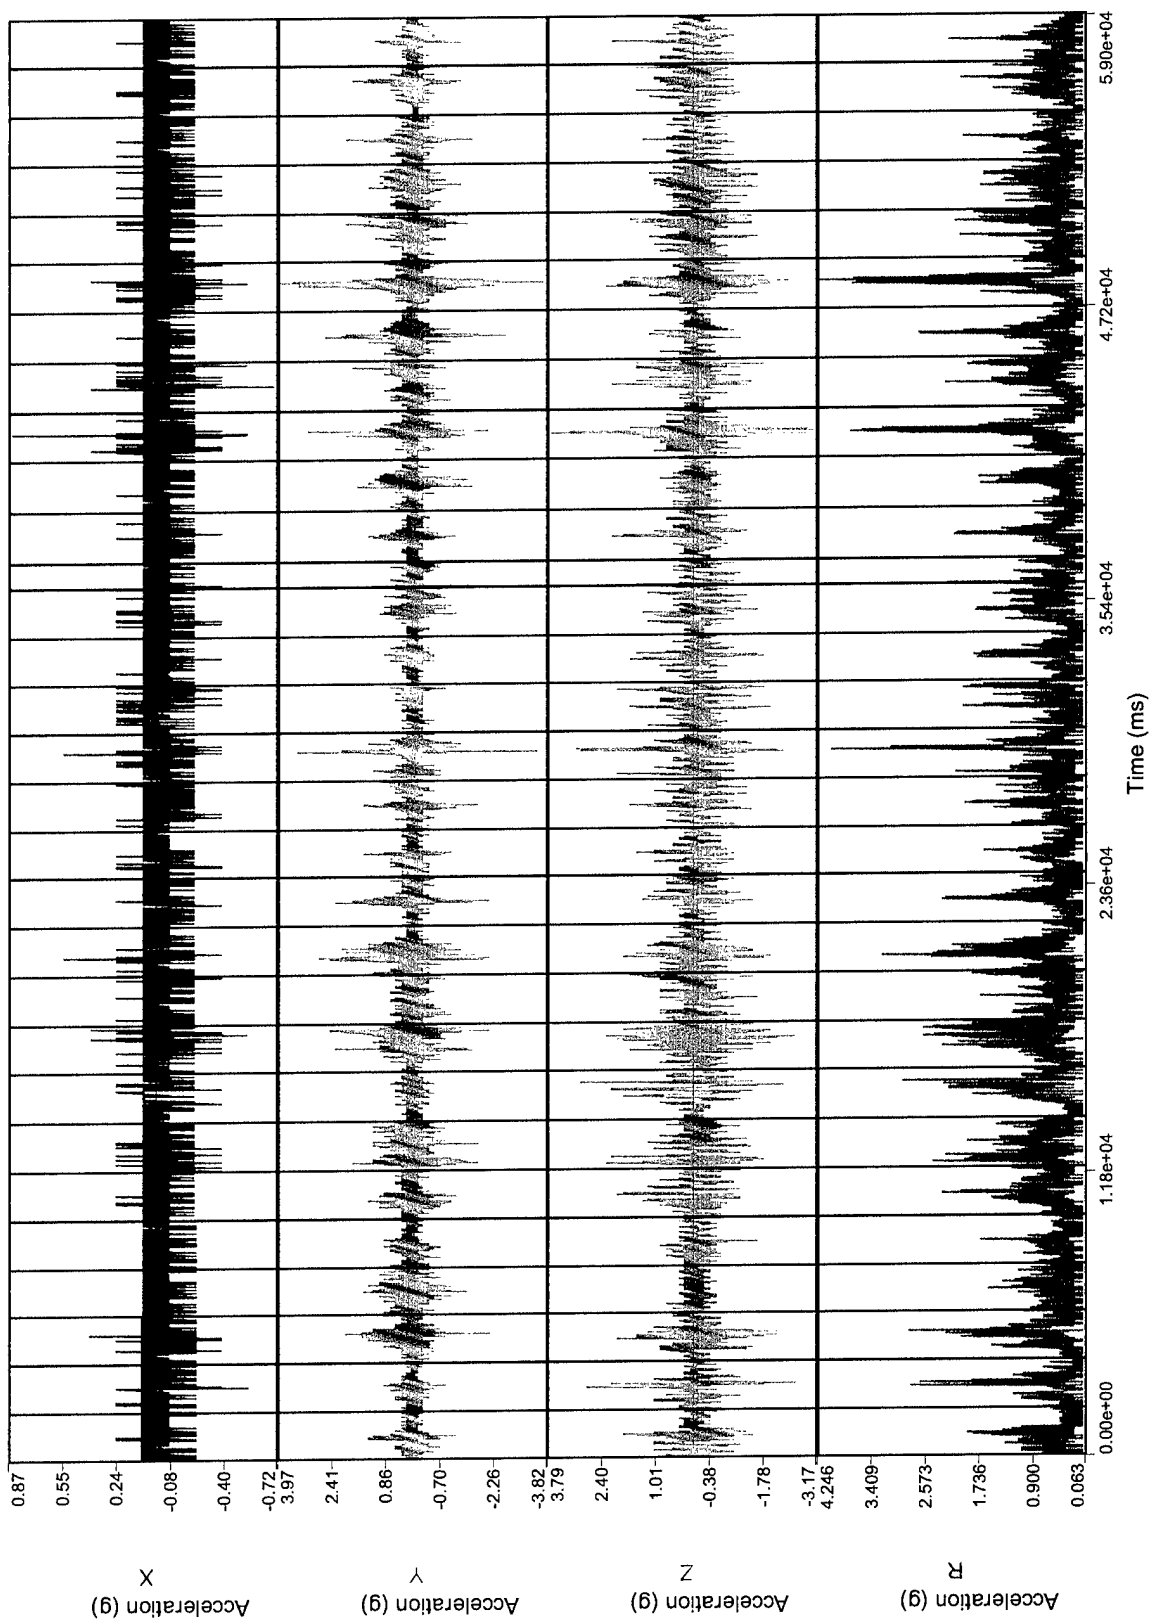
Road Trip of M87/A3 Trailer with 33,940-lb Payload      Sensor Location: Trailer Rear

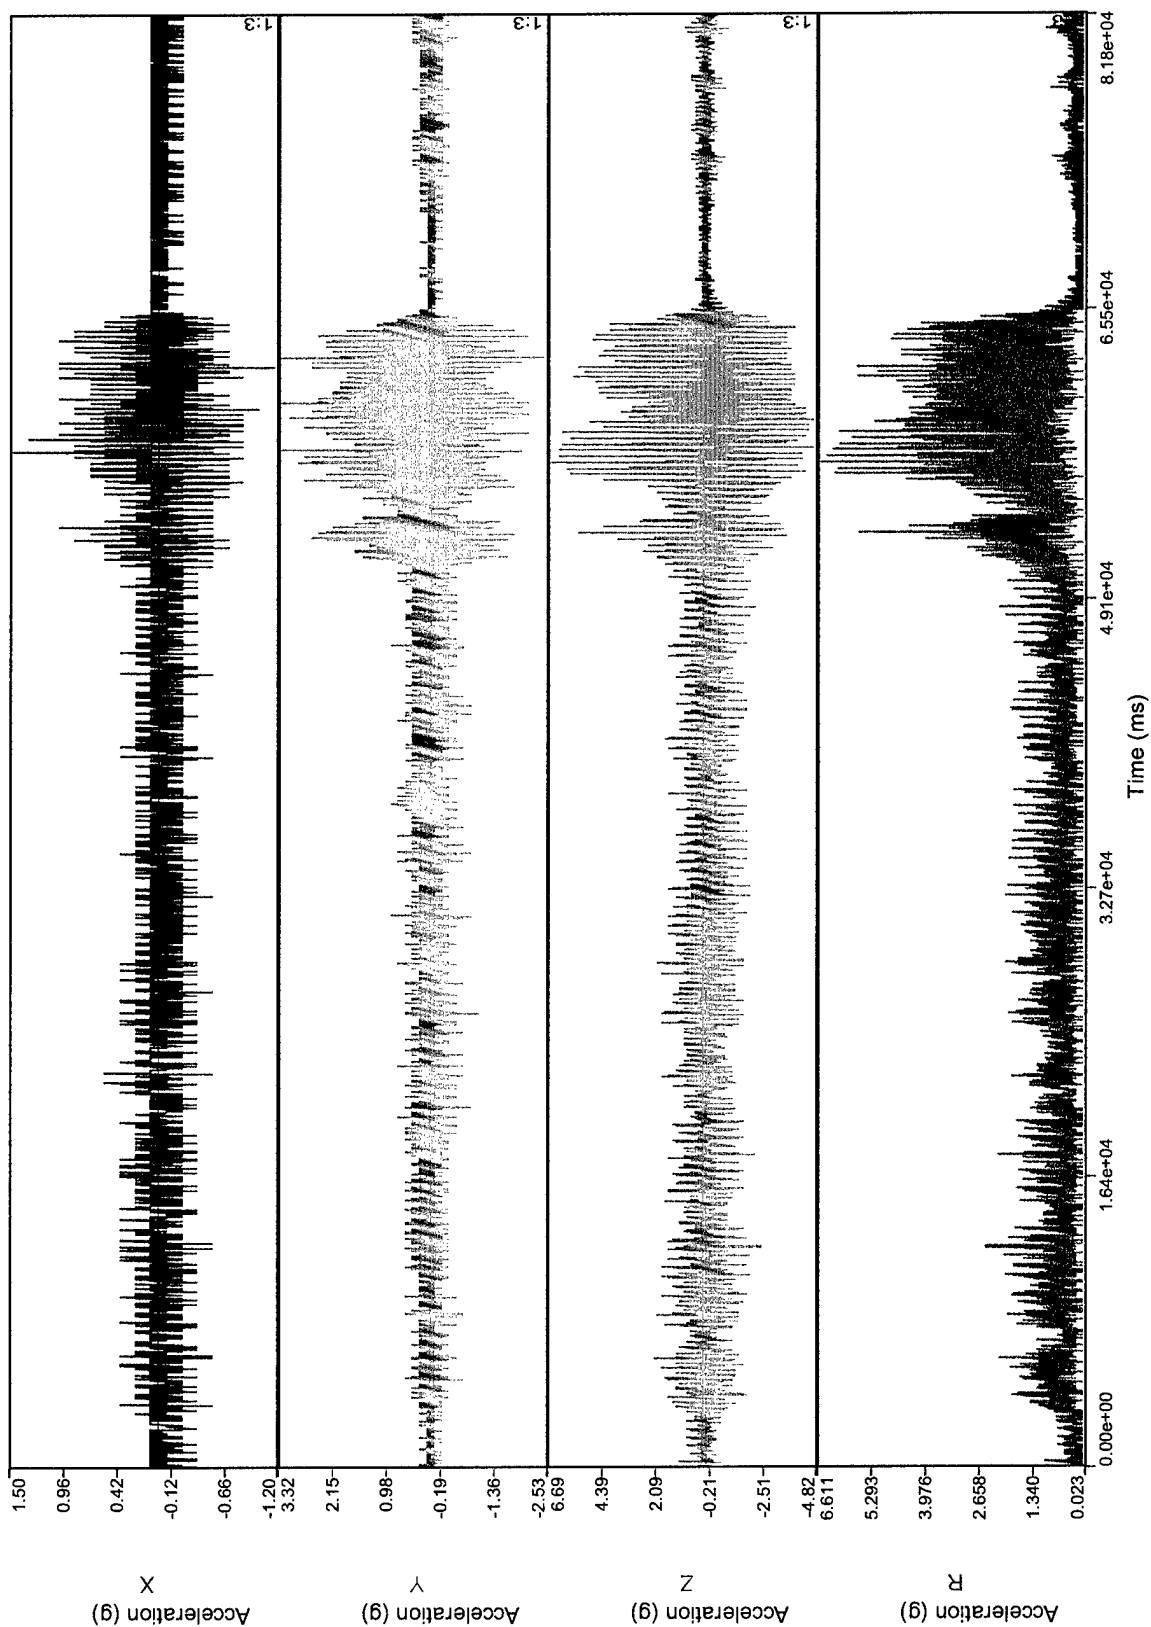
Washboard Course of M871A3 Trailer with 33,940-lb Payload      Sensor Location: Trailer Bulkhead
